MARINE INVESTIGATION REPORT
M99L0099

PILOT OVERBOARD

**WHILE DISEMBARKING FROM THE
CONTAINER SHIP “CANMAR VALOUR”
APPROACHING THE
LES ESCOUMINS PILOT STATION, QUEBEC
25 SEPTEMBER 1999**

Report Number M99L0099

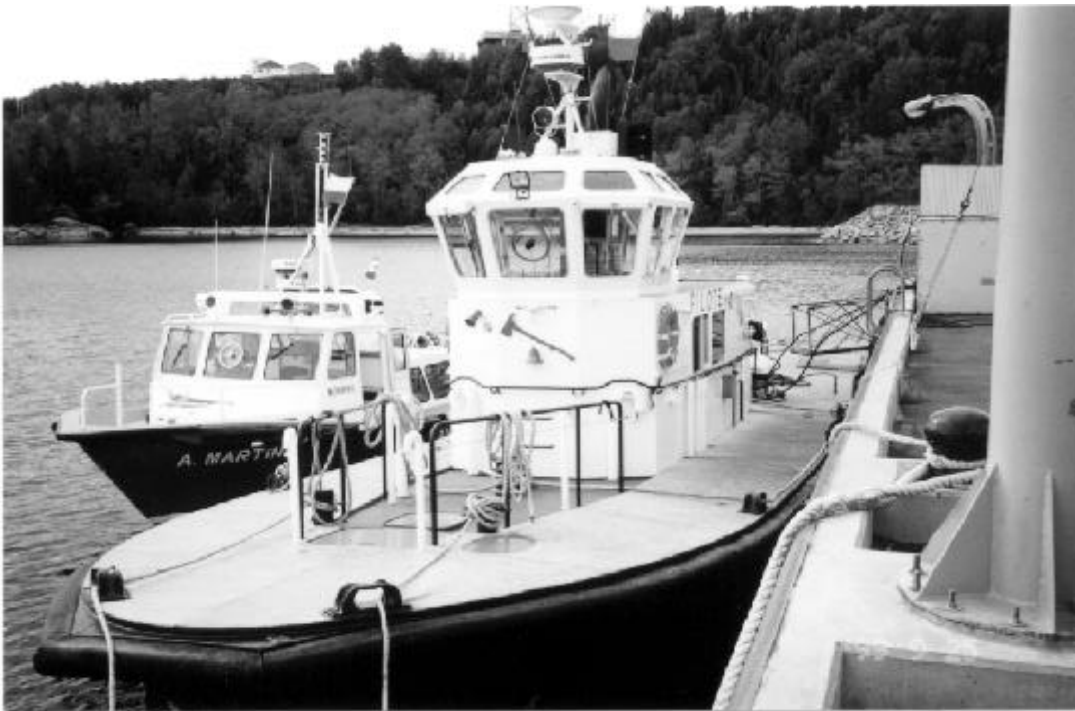
Photograph 1. Pilot boat “CHARLEVOIX” moored at the Les Escoumins pilot station.

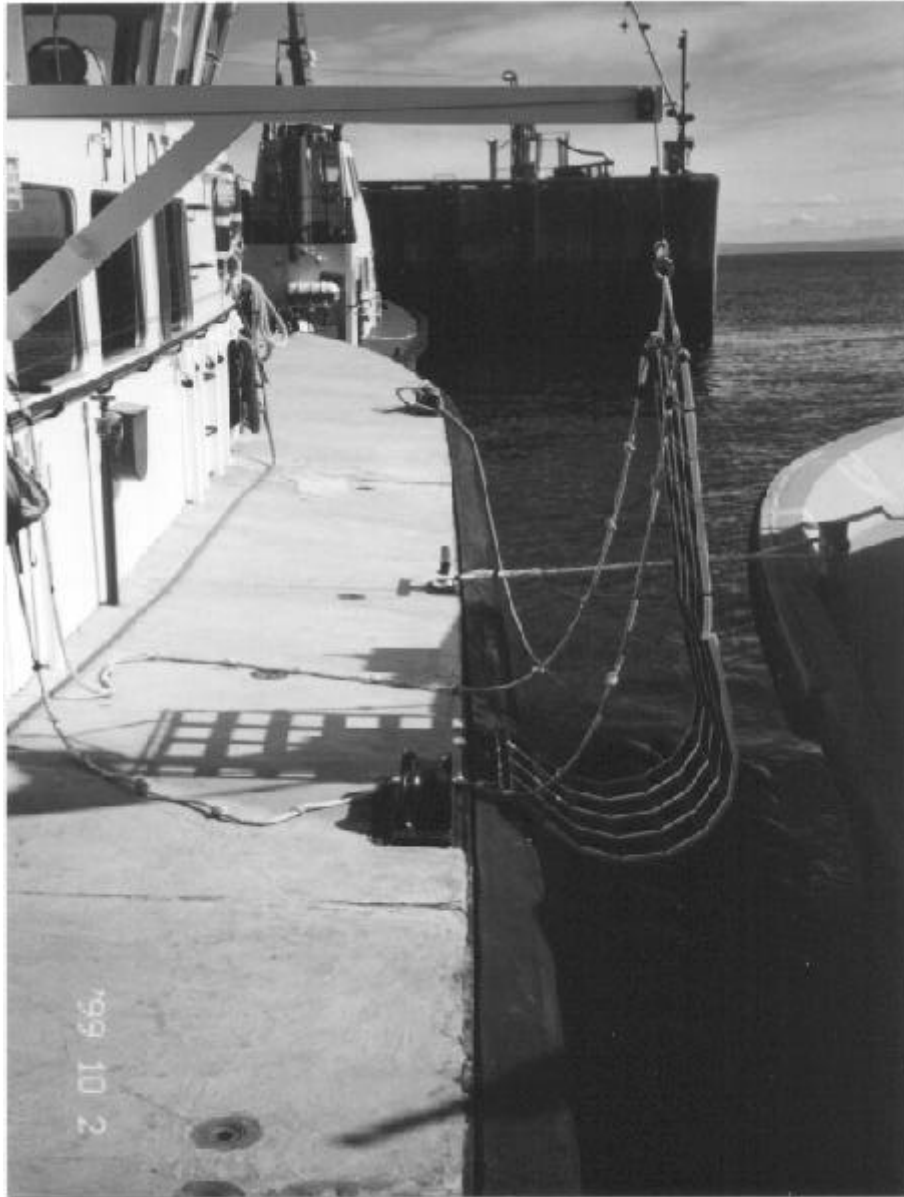
Since the pilot boat has a freeboard of 1.5 m, the end of the cradle reached only the surface of the water. The pilot tried to grab the cradle but was unable to hoist himself high enough to get a foot-hold on it. Since the hull is tilted, climbing to the deck is difficult and requires considerable effort. In light of this situation, and of the pilot being exhausted, the engineer on the deck was asked to help the others rescue the pilot. It was still difficult to hoist the pilot. The operator then came to help the others on the afterdeck. A mooring line was slipped under the pilot's arms and, after several attempts, the pilot was hoisted onto the deck after several minutes.

The Jason's cradle (recovery ladder) on the "CHARLEVOIX" is stowed in a compartment on the main deck. Thus, it must be retrieved from the compartment, opened, and rigged by hooking two snap links through the eyes provided on the deck edge. To deploy the device in the shape of a cradle, the bottom of the ladder must be held in place by the line coming from the boom winch.

5. The recovery device was not permanently installed to allow rapid deployment in an emergency.
6. Practice drills in man overboard recovery are not part of a regular training program on the "CHARLEVOIX".

Photograph 2. Jason's cradle temporarily rigged on the "CHARLEVOIX".

- The Jason’s cradle will be installed permanently on the “CHARLEVOIX” when it next goes into dry dock.
- The hand winches were modified in the days following the occurrence.
- An exercise program and calendar were prepared, and a chart posted on the boat must be signed by the master after each exercise.
- The crew received training on the use of recovery equipment, and all personnel assigned to pilot boats should receive Marine Emergency Duties II (MED II) by the end
